**Important Instructions  
for Brake System Repairs  
VOLKSWAGEN 1200**

**Slide Series № 2**

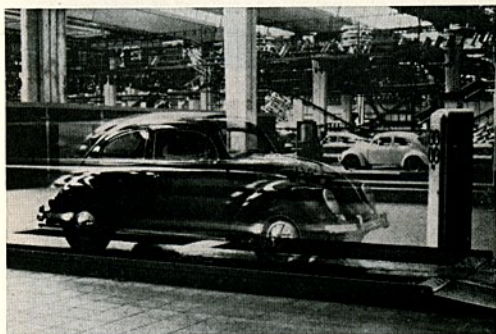
**2/10** A properly functioning brake system is of great importance to the road safety of a vehicle. For this reason, the brakes of every Volkswagen are tested before it leaves the factory. The braking effect of each individual wheel is recorded on the four gauges on the brake test stand measuring column which is visible on the right of the picture. As soon as the vehicle leaves the factory, the task of maintaining its roadworthiness by conscientious care is in the hands of the VW specialist.

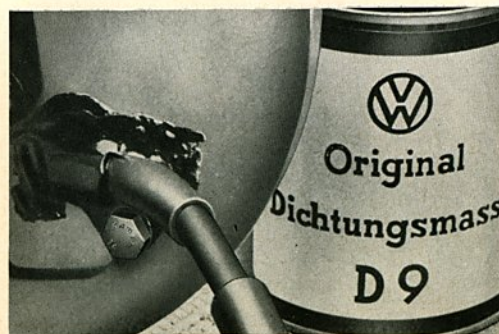
**2/380** Moisture which occasionally enters the brake drum can cause the pin for the lever of the handbrake linkage to seize. When this happens, the brakes stay on when the handbrake is released. In such cases it is advisable to fit a galvanized pin and not to just free the linkage off.

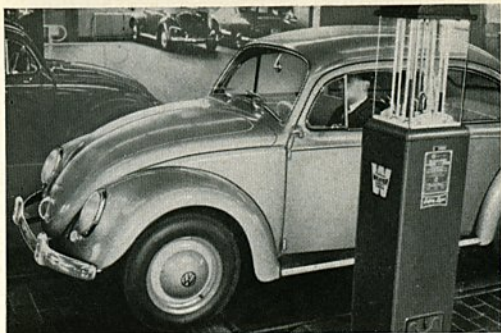
**2/400** When the repairs to the brake system have been completed, the brakes must be tested. If a modern brake testing stand is available, the braking force at each wheel can be read off from the height of the four columns of liquid. The exercise of the necessary care in all repair and checking operations on the brake system is an indispensable condition for road safety and is one of the most important tasks afor the VW specialist.

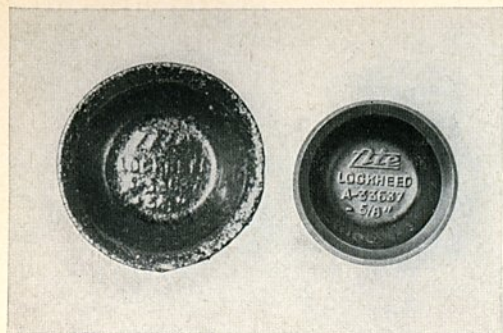
**2/200** All the other rubber parts in the hydraulic brake system are equally susceptible to damage from mineral oils. This picture shows a cup which is swollen due to the influence of mineral oil compared with a good cup.

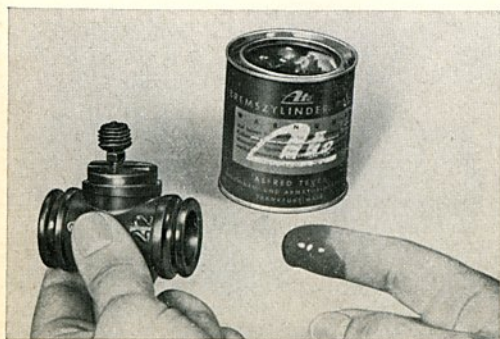
**2/210** This is why the rubber parts and other parts of the cylinders should never be washed in gasoline, benzine or kerosene. Apart from brake fluid itself, the only other liquid to be used is methylated spirits. After cleaning with meths, the parts must be dried thoroughly.

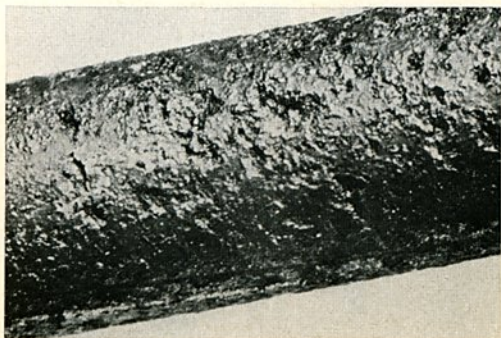
**2/240** This is not a picture of an excavation find dating back to early Roman times, but a very much enlarged view of a rusty brake line. The effects of weathering over a period of several years service can make this brake line just as dangerous as a pipe which is badly chafed, kinked or flattened by stone damage.
